Fire Examination Reports and FAA Testing Reports

Fire Examination Report (Original On-scene 7/6/13)

Fire Examination Report (Follow-up on-scene visit 8/21-22/13)

Fire Test Results for Asiana 214 Materials

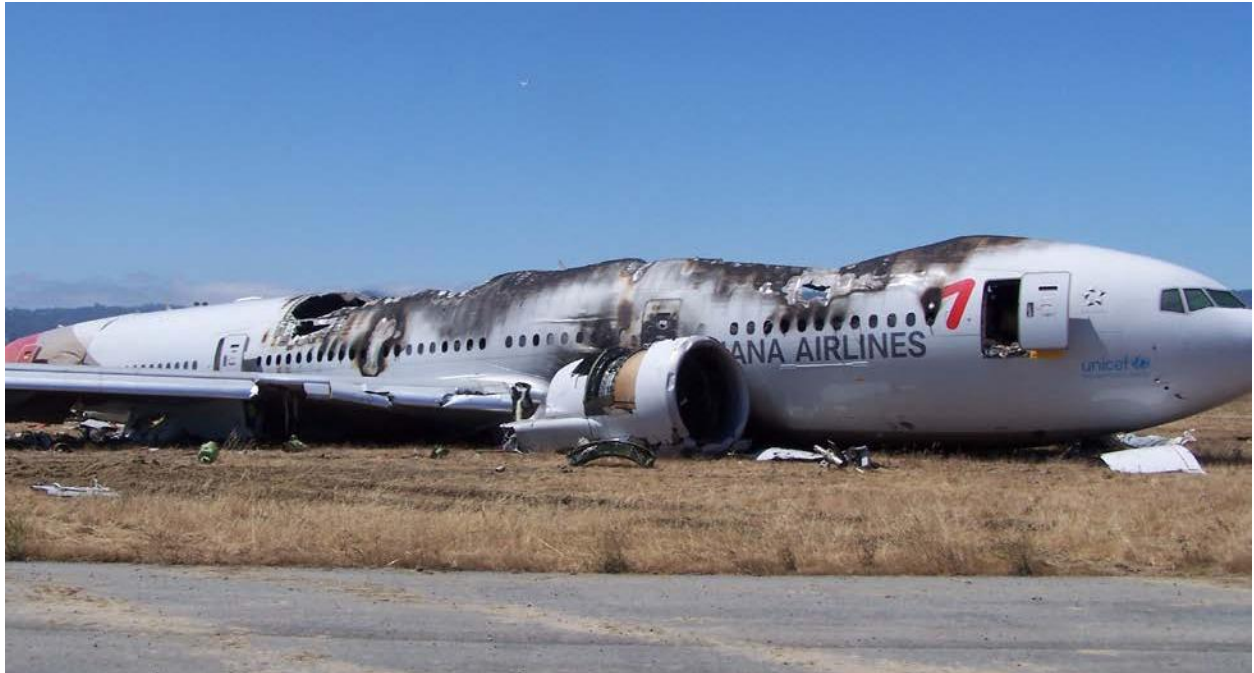
Figure 1. Photograph of accident aircraft.

The crown was burned through from approximately Door 1 (STA 410) to Door 2 area (STA 951) and Door 2 area (STA1056) to Door 3 (STA 1497).

Engine number 2 ended up with its 6 o'clock position against the fuselage on the right side of airplane at STA 825, next to a bay without a window (due to ECS riser ducts).

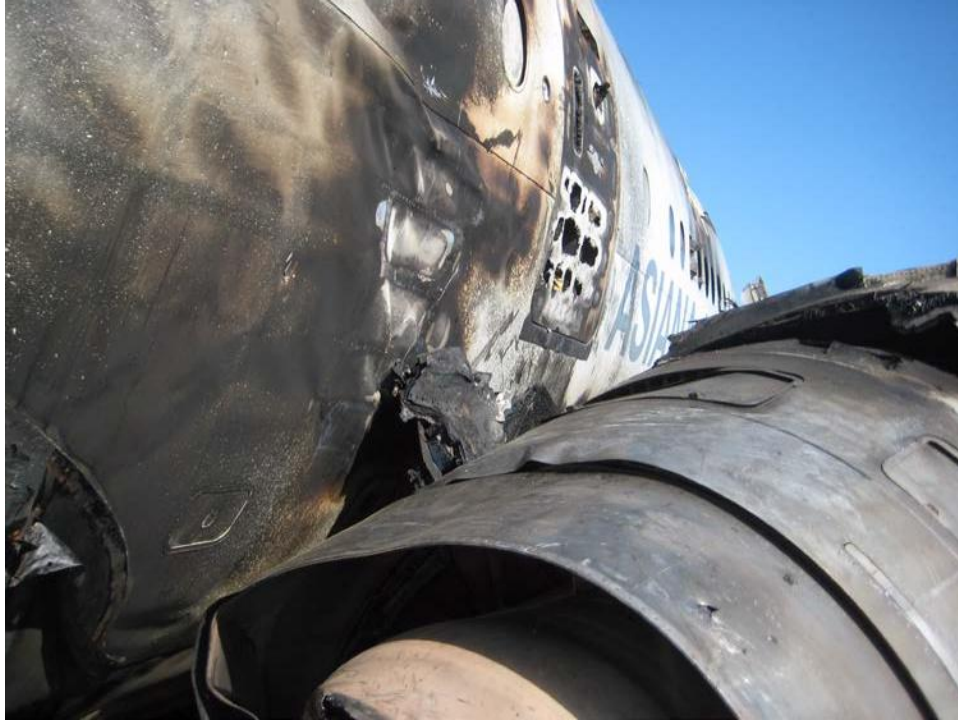
There were varying amounts of skin discoloration and heating from STA 718 to STA 930. The door 2R external skins were burned away to the midpoint, but the fire did not penetrate internal insulation and mechanisms into the cabin.

Figure 2. Photograph of fire damage to right hand side of fuselage (facing forward).

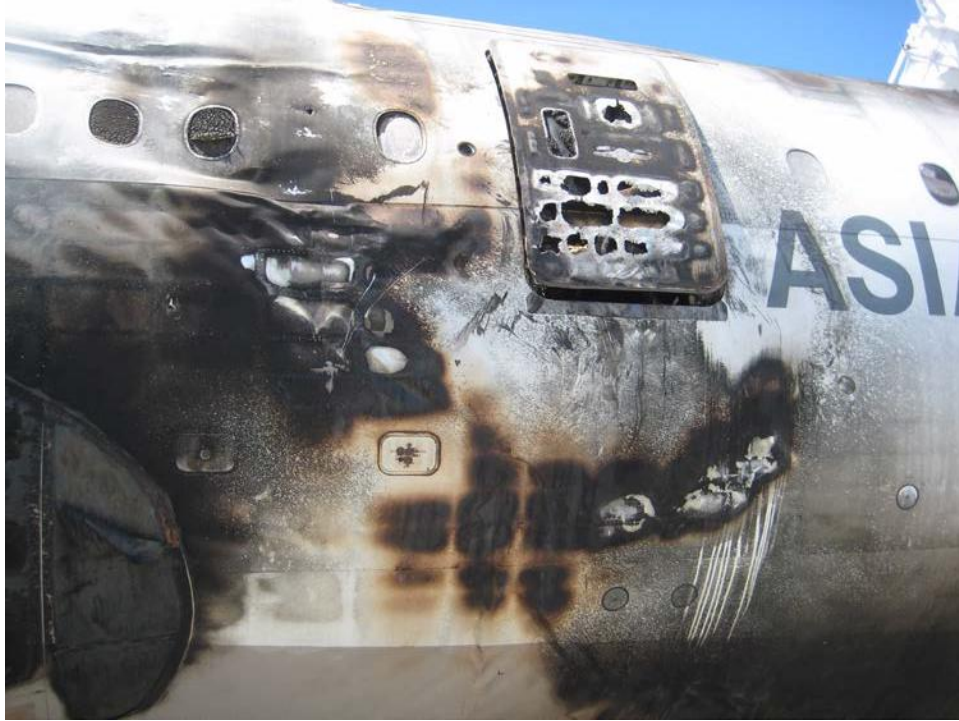
Figure 3. Photograph of Door 2 Right.

Inspection of the engine with the powerplant group showed that the oil tank that was now on top of the engine had been compromised. The oil burned adjacent to the fuselage and door 2R. The fuselage in the area showed severe heat damage but no penetrations other than rivet holes and minor cracks. Examination of the accident site and fuel tanks (wings and center) showed no additional postcrash fire involving fuel.

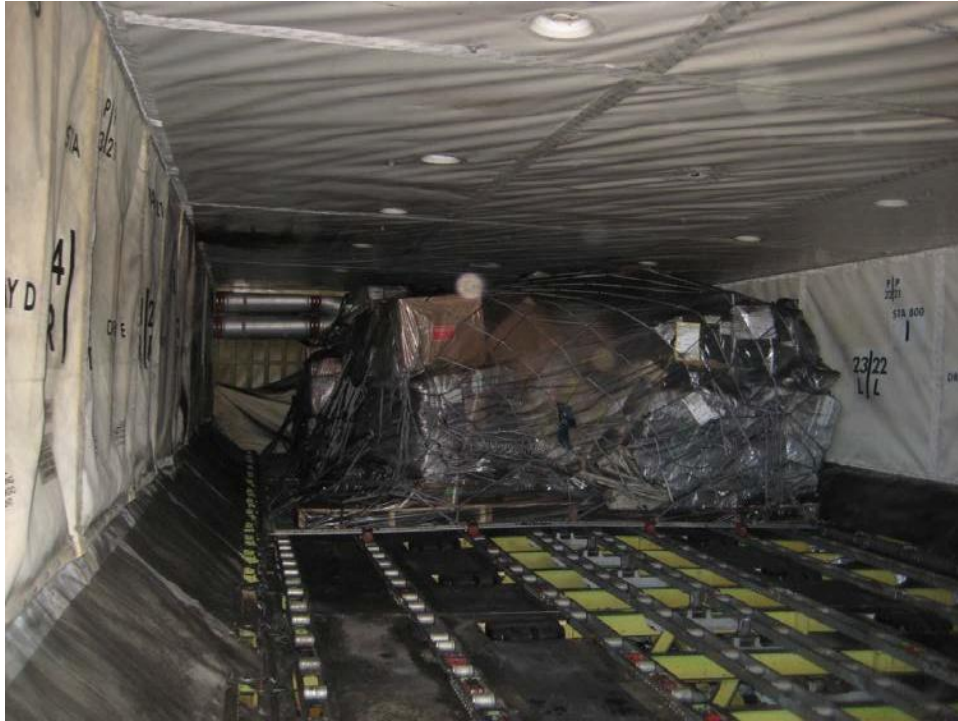
Figure 4. Photograph of forward cargo compartment.

There was evidence of smoke throughout the compartment and in the bilge.

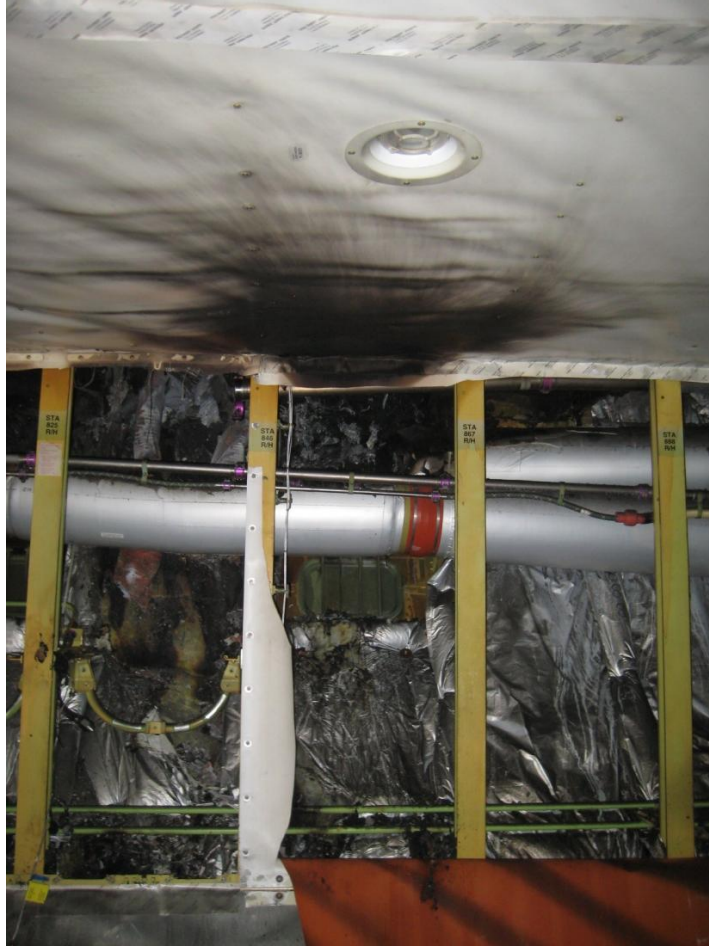
Inspection of the RH cheek area in the forward cargo compartment shows that the heat from the engine fire transferred through the skin. Insulation and ECS riser ducts at STA 825 – 846 and STA 846 – 867 show extensive fire damage.

Figure 5. STA 825 – 888 R/H forward cargo compartment (looking outboard).

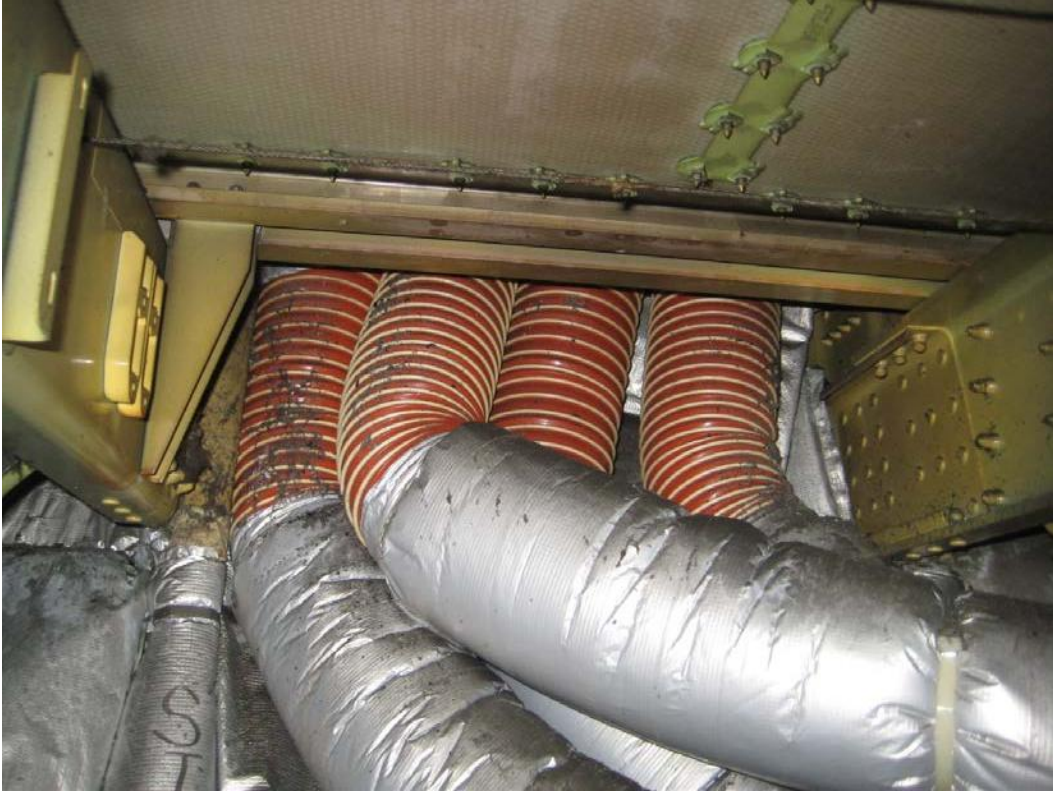
Figure 10. STA 676 - 697 R/H riser ducts appeared undamaged by fire.

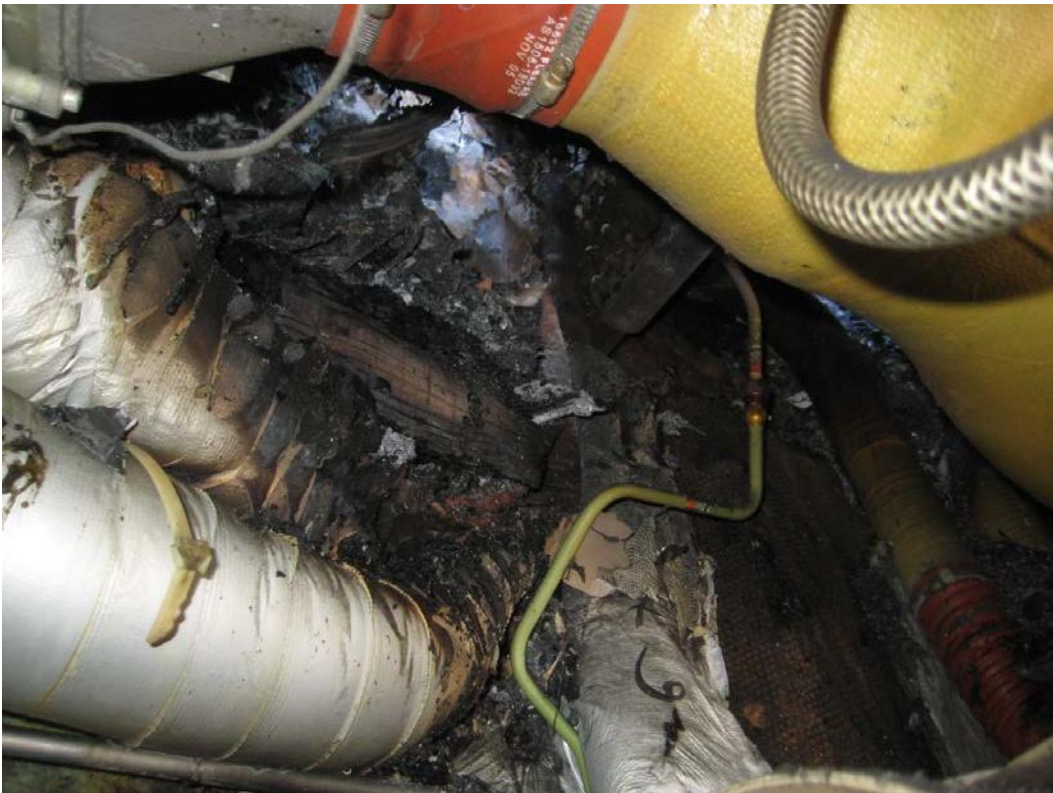
Figure 11. STA 676 - 697 L/H rider ducts damaged by fire.

Main cabin fire damage extended from just forward of door 1 aft to above door 3. For additional documentation of the fire damage to the main cabin, see the survival factors group chairman's factual report. Burn damage showed evidence of higher temperatures in the areas of the ECS riser ducts at STA 676 – 697 L/H, STA 972 – 993 L/H and STA 972 - 993 R/H. Smoke and heat damage in the crown extended back to the pressure dome.

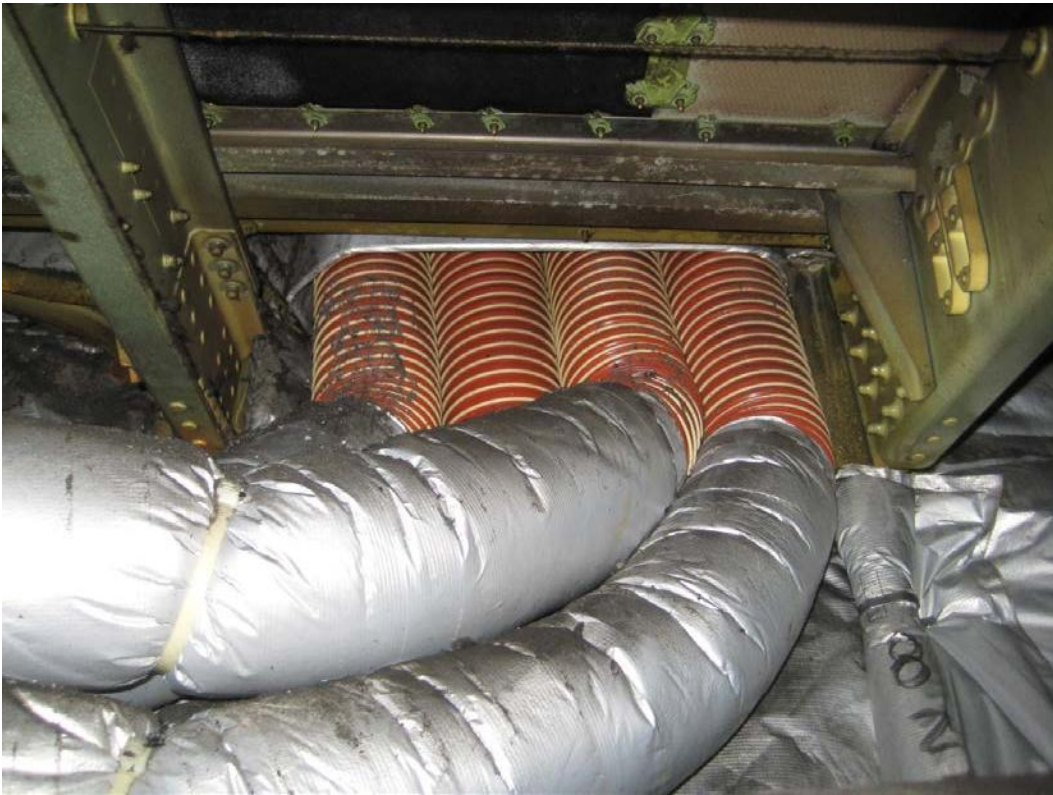
Figure 12. Riser Ducts at STA 825 - 846 L/H riser ducts appeared undamaged by the cabin fire

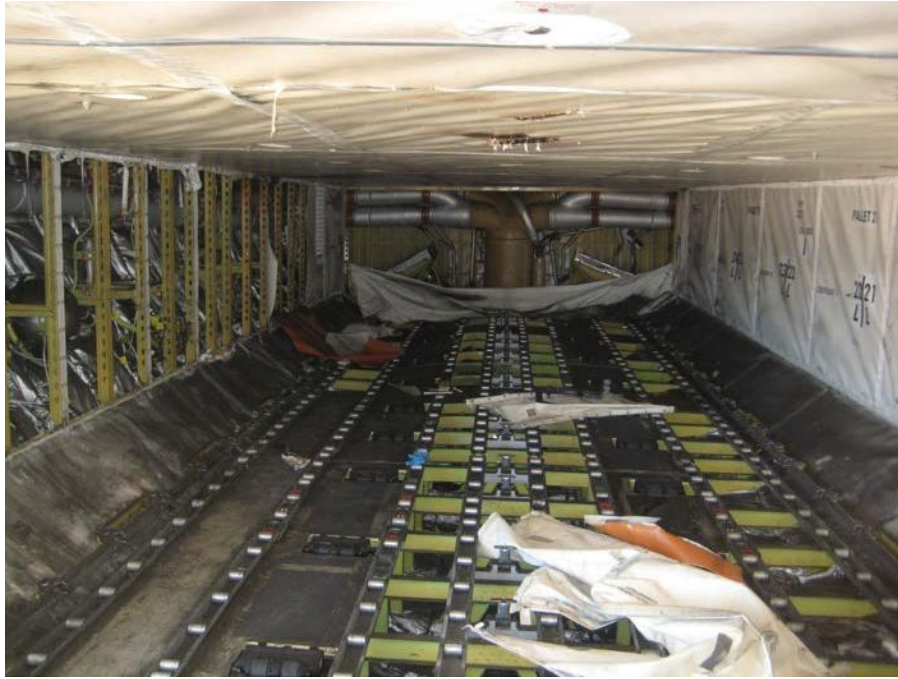
Figure 13. Aft wall at STA 998

The aft soft liner had detached from the top edge for the full width and was about 50% open.

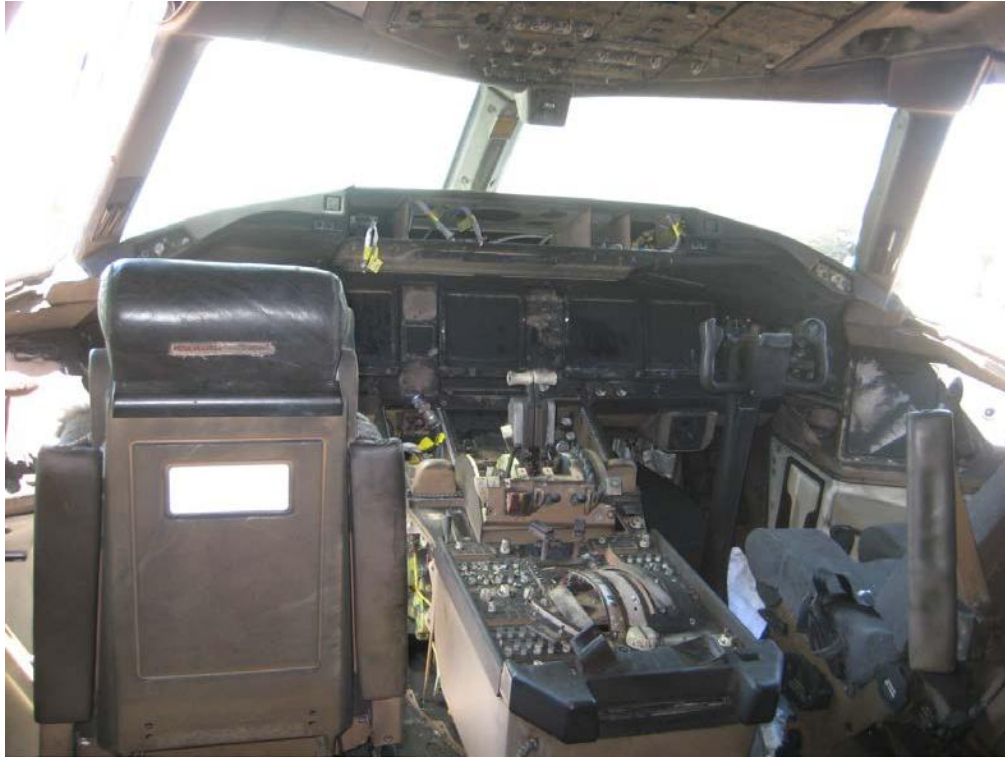
Figure 14. Photograph of flight deck.

Smoke and heat damage was extended into the flight deck. There was an open access panel in the aft ceiling area of the flight deck at STA 246.

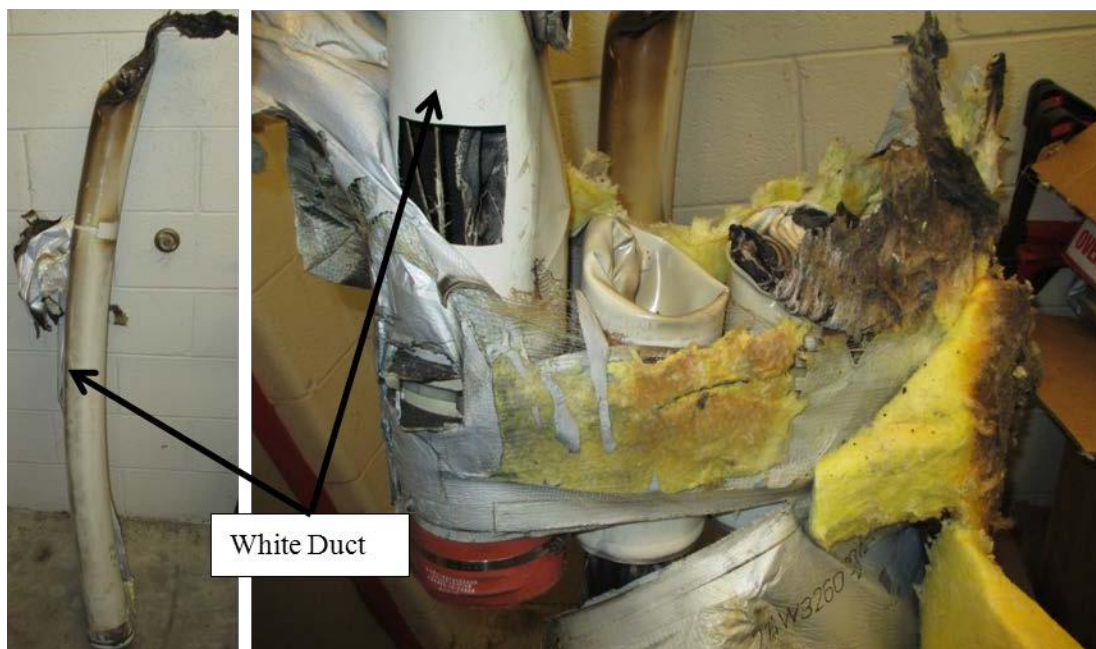
The term “White Duct” is used to describe rigid, curved ducts that connect to the flexible red duct behind the sidewall panels above the floor. The white ducts are 4 inches in diameter, and are arranged side-by-side behind the sidewall panel in the ECS riser bay. The white duct is believed to be constructed from Ultem™ thermoplastic polyetherimide (PEI) resin. The white ducts are wrapped in insulation blankets over portions of their lengths. When recovered from the accident aircraft, most of the white ducts in the aircraft were mostly melted and disfigured beyond recognition; only two approximately five-foot sections were undamaged and usable for fire testing.

Figure 18. Photograph of the “White Ducts” recovered from the aircraft. Note that most of the ducts had melted inwards.

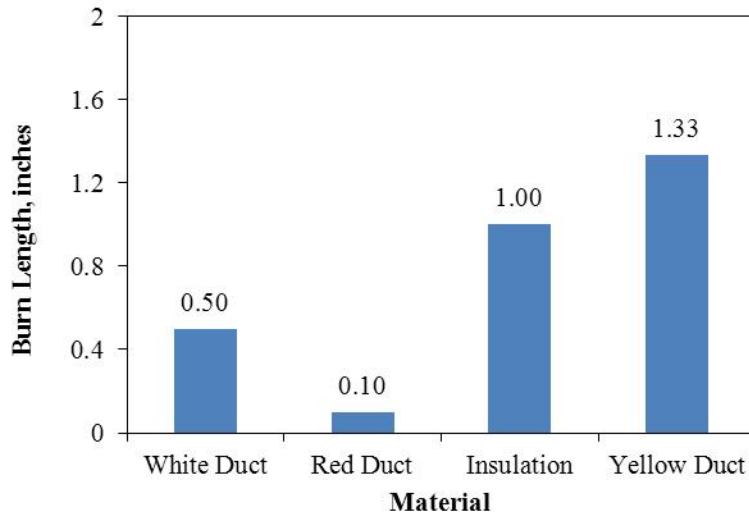
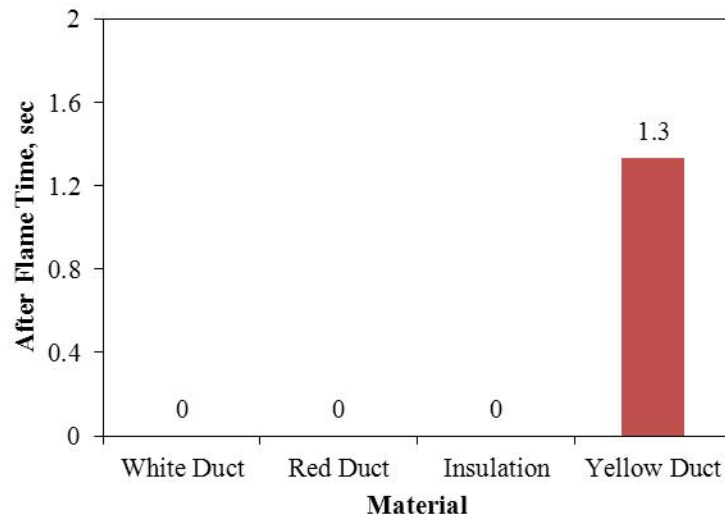
The test results from the Bunsen burner tests for all materials are presented in Figure 9 and Figure 10, displaying average burn length and average after flame time, respectively. Three samples of each material were tested, and the results were averaged. All materials passed the test, as the maximum allowable burn length is eight inches, and the maximum allowable after flame time is fifteen seconds, and there were no flaming drips. All of the materials tested were required to meet the vertical Bunsen burner test according to 25.853.

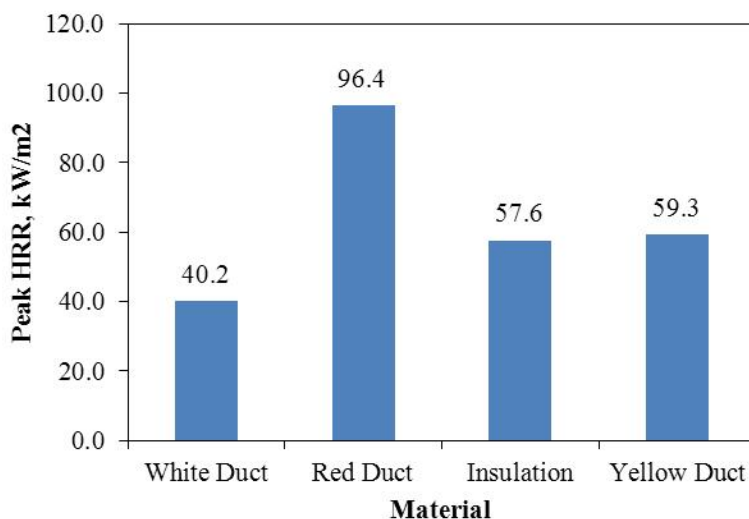
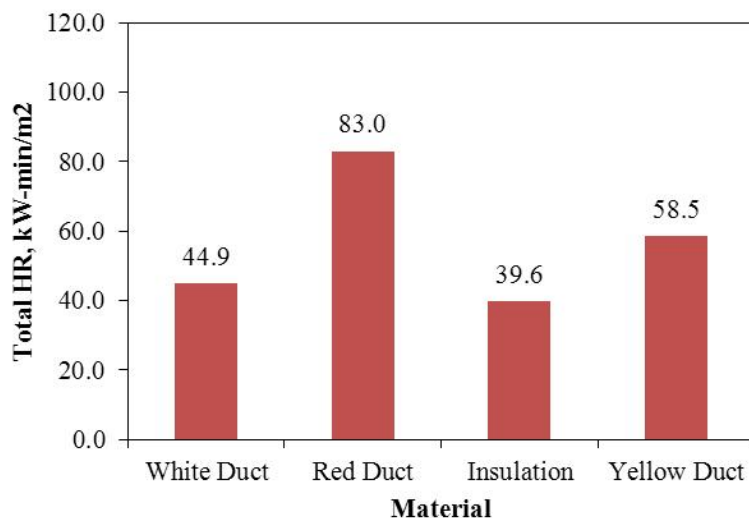
The results from the OSU testing are presented in Figure 11 and Figure 12, displaying the average peak heat release rate and average total heat release rate, respectively. Three samples of each material were tested, and the results were averaged. Three of the materials, white duct, yellow duct, and insulation passed both peak and total heat release, while the red duct failed both peak and total heat release, having values higher than 65. It must be noted that none of these

materials are required to meet the OSU test for certification; it was only used to determine the effect of a more severe fire test method on materials that all pass the vertical Bunsen burner test.

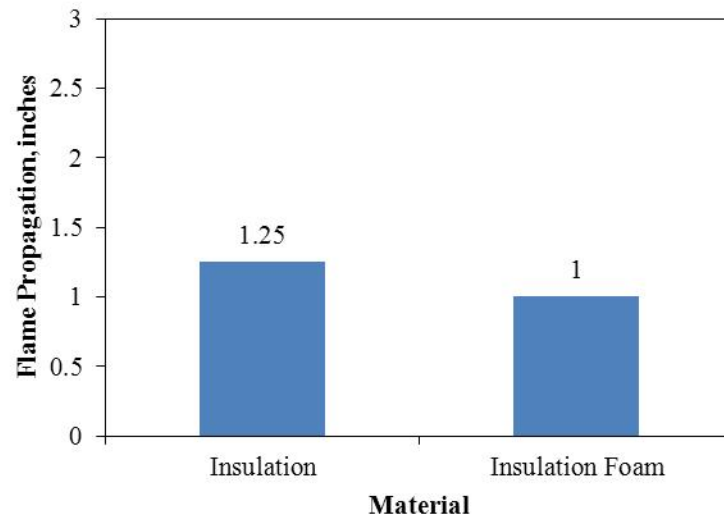
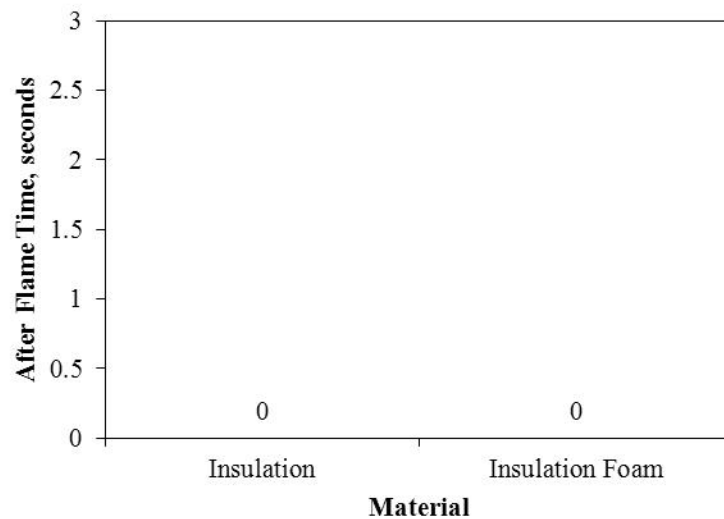
The results from the radiant panel test are presented in Figure 13 and Figure 14, displaying measured flame propagation and observed after flame time, respectively. Only the insulation material was tested in the radiant panel test, as it is the only material of those salvaged that is required to meet this test method on this airplane. Since the radiant panel requires relatively large sample sizes, twelve by twenty four inches, only two tests were performed, one with the

film side facing up and the other with the insulating foam side facing up. Regardless of the side tested, both tests had measured flame propagation less than two inches and observed after flame time less than three seconds.

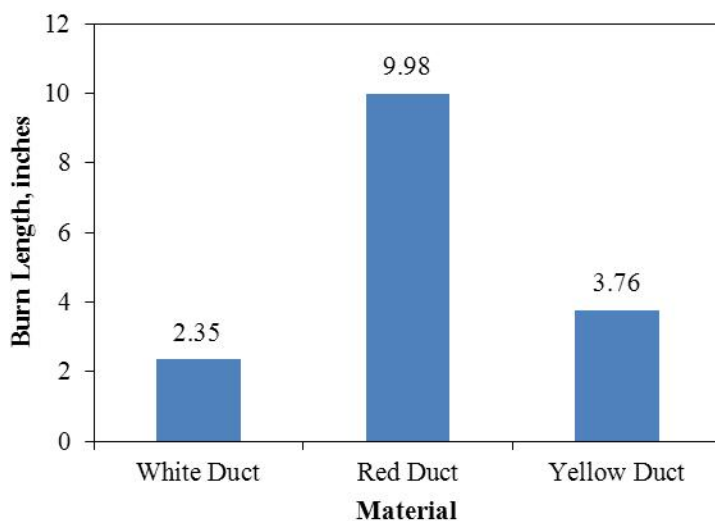
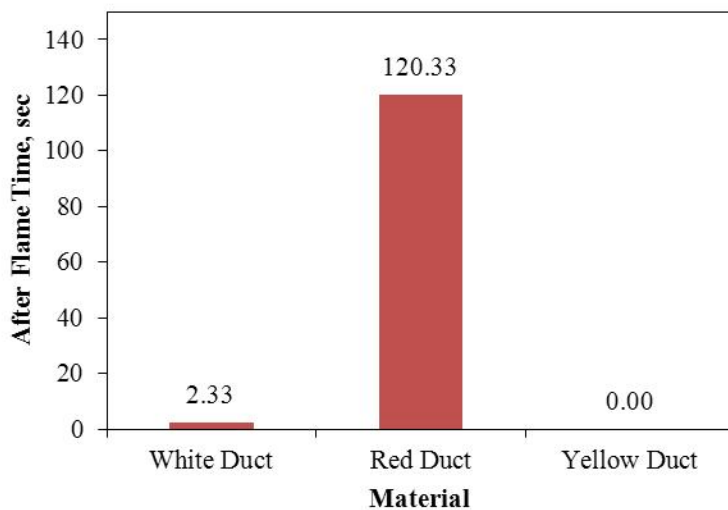
materials were tested in this apparatus, as there were not sufficient quantities of insulation to test and the insulation was already found to pass the stringent radiant panel test for insulation. The results from the vertical flame propagation test indicate that the red duct was more likely to propagate flames under these conditions. Similar to the OSU results, the red duct could be considered a material of poor fire resistance when tested to conditions more severe than the vertical Bunsen burner test.

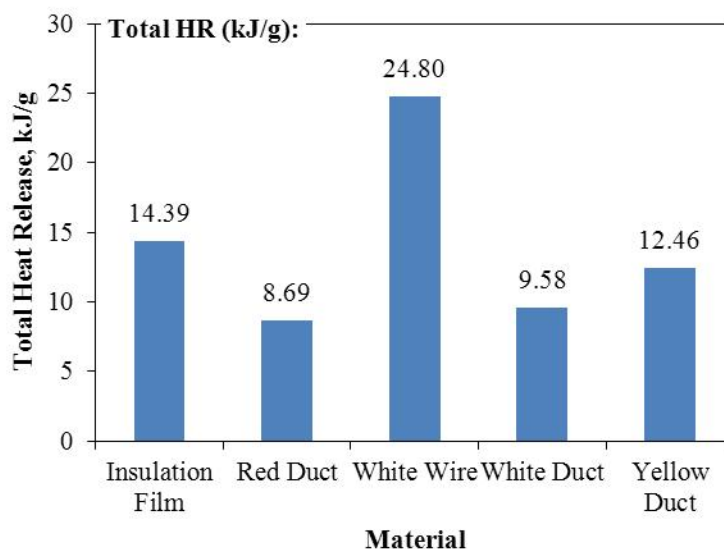
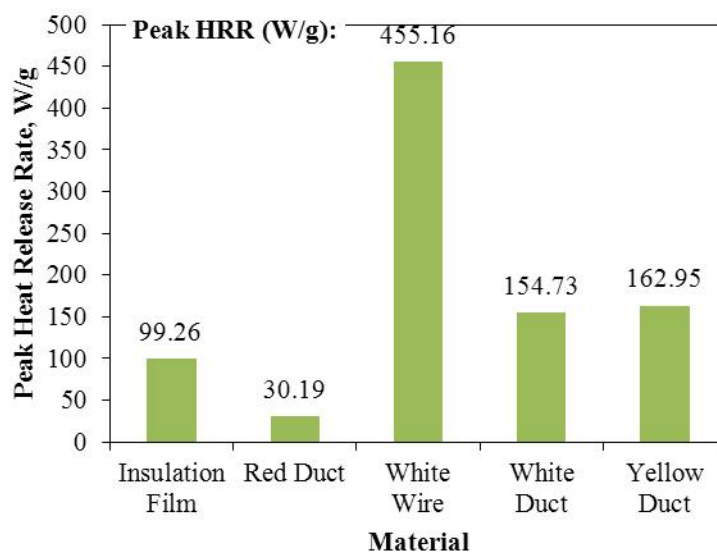
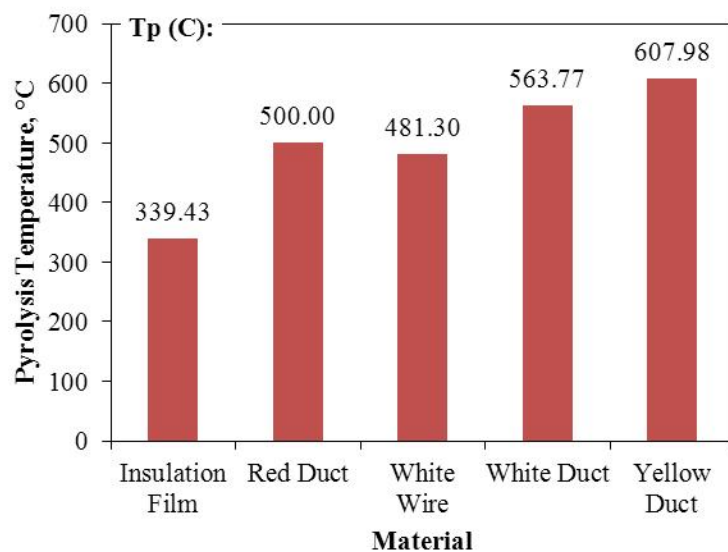
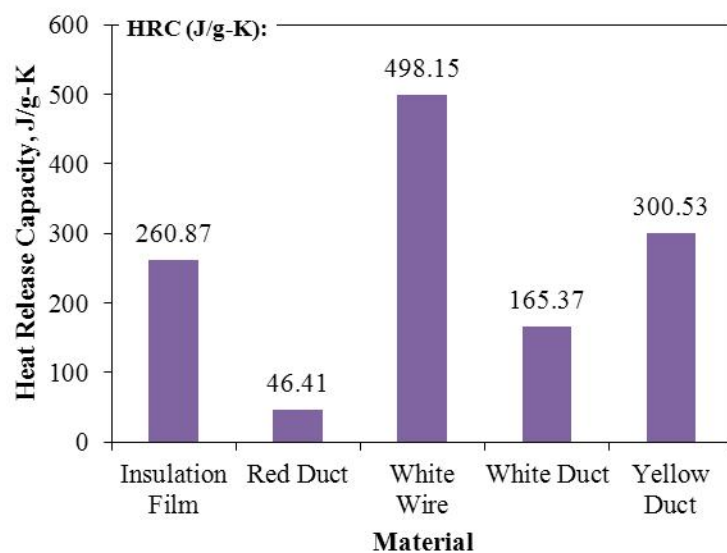
The results from the Microscale Combustion Calorimeter are presented in Figure 17 through Figure 20, displaying total heat release, peak heat release rate, pyrolysis temperature, and heat release capacity. Since the sample size is small for this test, the red duct was separated into two different samples – the red silicone fiberglass duct and the white reinforcing spiral ring, as indicated in Figure 21. The figures indicate that the white reinforcing spiral wire is the most flammable of all materials, measuring the highest total heat release, peak heat release rate, and heat release capacity.

Of all the materials tested, the red flexible duct displayed the poorest fire performance when introduced to test methods more severe than the vertical Bunsen burner test that is required for certification. The MCC test results indicated that the white reinforcing spiral wire was actually the most flammable component of the red duct, and when it begins to combust a significant amount of heat is released. This behavior was also observed in the OSU and the vertical flame propagation apparatus, where the radiant heater added significantly more energy to the surface of the sample, elevating the temperature of the red duct and white wire, resulting in self-sustaining flaming combustion and flame propagation along the sample surface. Although the red duct displayed poor fire performance in these tests, the criteria for certification still remains a twelve second vertical Bunsen burner test. Therefore, the material meets and exceeds the current certification criteria for flammability.
